# ALERT

## Temporary Traffic Management and Level Crossing Interface – Alert to Roading Control Authorities

Issue No.	11	Issue date:	22/03/2021	Originator:	Zero Harm
ORA No.	EVT2001083EVT2001083			BU reference:	ZH CPAD 003
Content endorsed by:	KiwiRail			Related docs:	Code of Practice for Temporary Traffic Management
Content authorised by:	Cat Salt, KiwiRail			Job title:	Zero Harm Lead

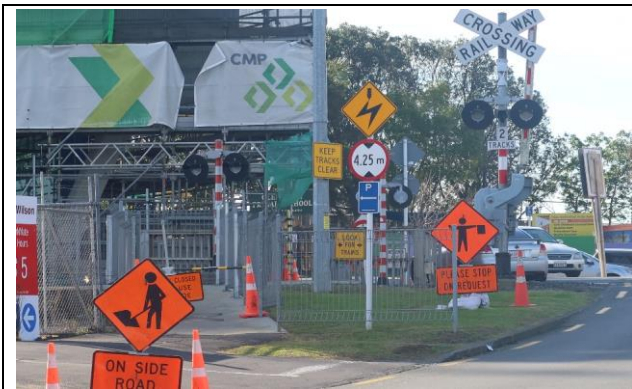
Example of confusing signage as approaching a level crossing.

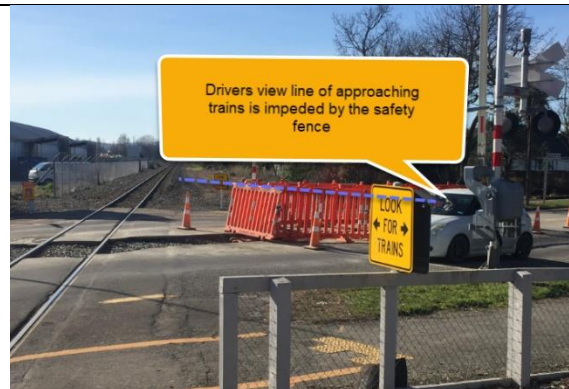
Example of driver view lines where fencing is used in proximity to the rail corridor

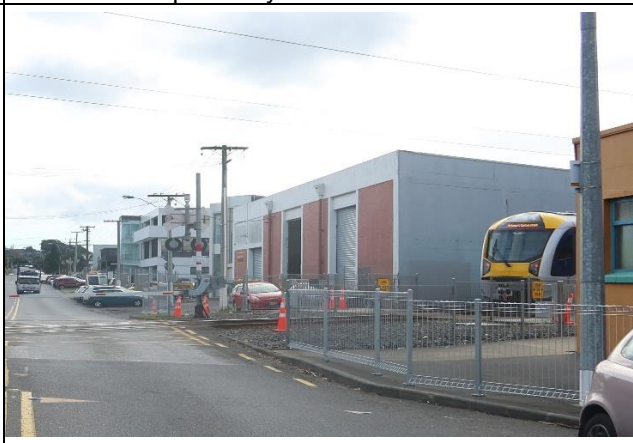
View of signalling when crossing is activated on the wrong side of the road (half-arm barrier has very low visibility and flashing lights are not observable)

- Road users do not have visibility of barrier arms activating, warning lights and signage when crossing on the wrong side of a level crossing.
- Stop/Go instructions create confusion for road users when the worksite incorporates part of the crossing.

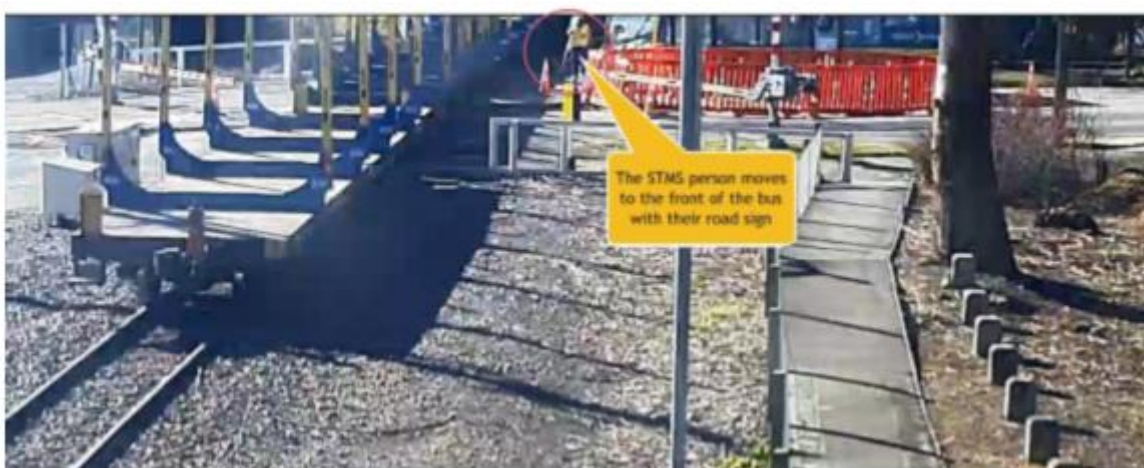
A temporary traffic management system had been established for excavation work being undertaken on Renall Street. The system diverted road users through side roads away from the crossing. A passenger bus service was granted special permission supported by the local council to travel through the worksite and over the wrong side of the crossing. A passenger bus approached the crossing as the half-arm barrier activated blocking the bus from exiting the crossing. The driver stopped the bus and reversed clear of the tracks. Less than 10 seconds later a freight train proceeded over the crossing. As the train is proceeding over the crossing the STMS placed themselves between the front of the bus and the passing train wagons shown in figure 10 below.

Figure 10: STMS person positioned near the front of the bus.

Rail protection and bulletins are required to protect people from rail movements where activity is underway within 5m of the track centre line.

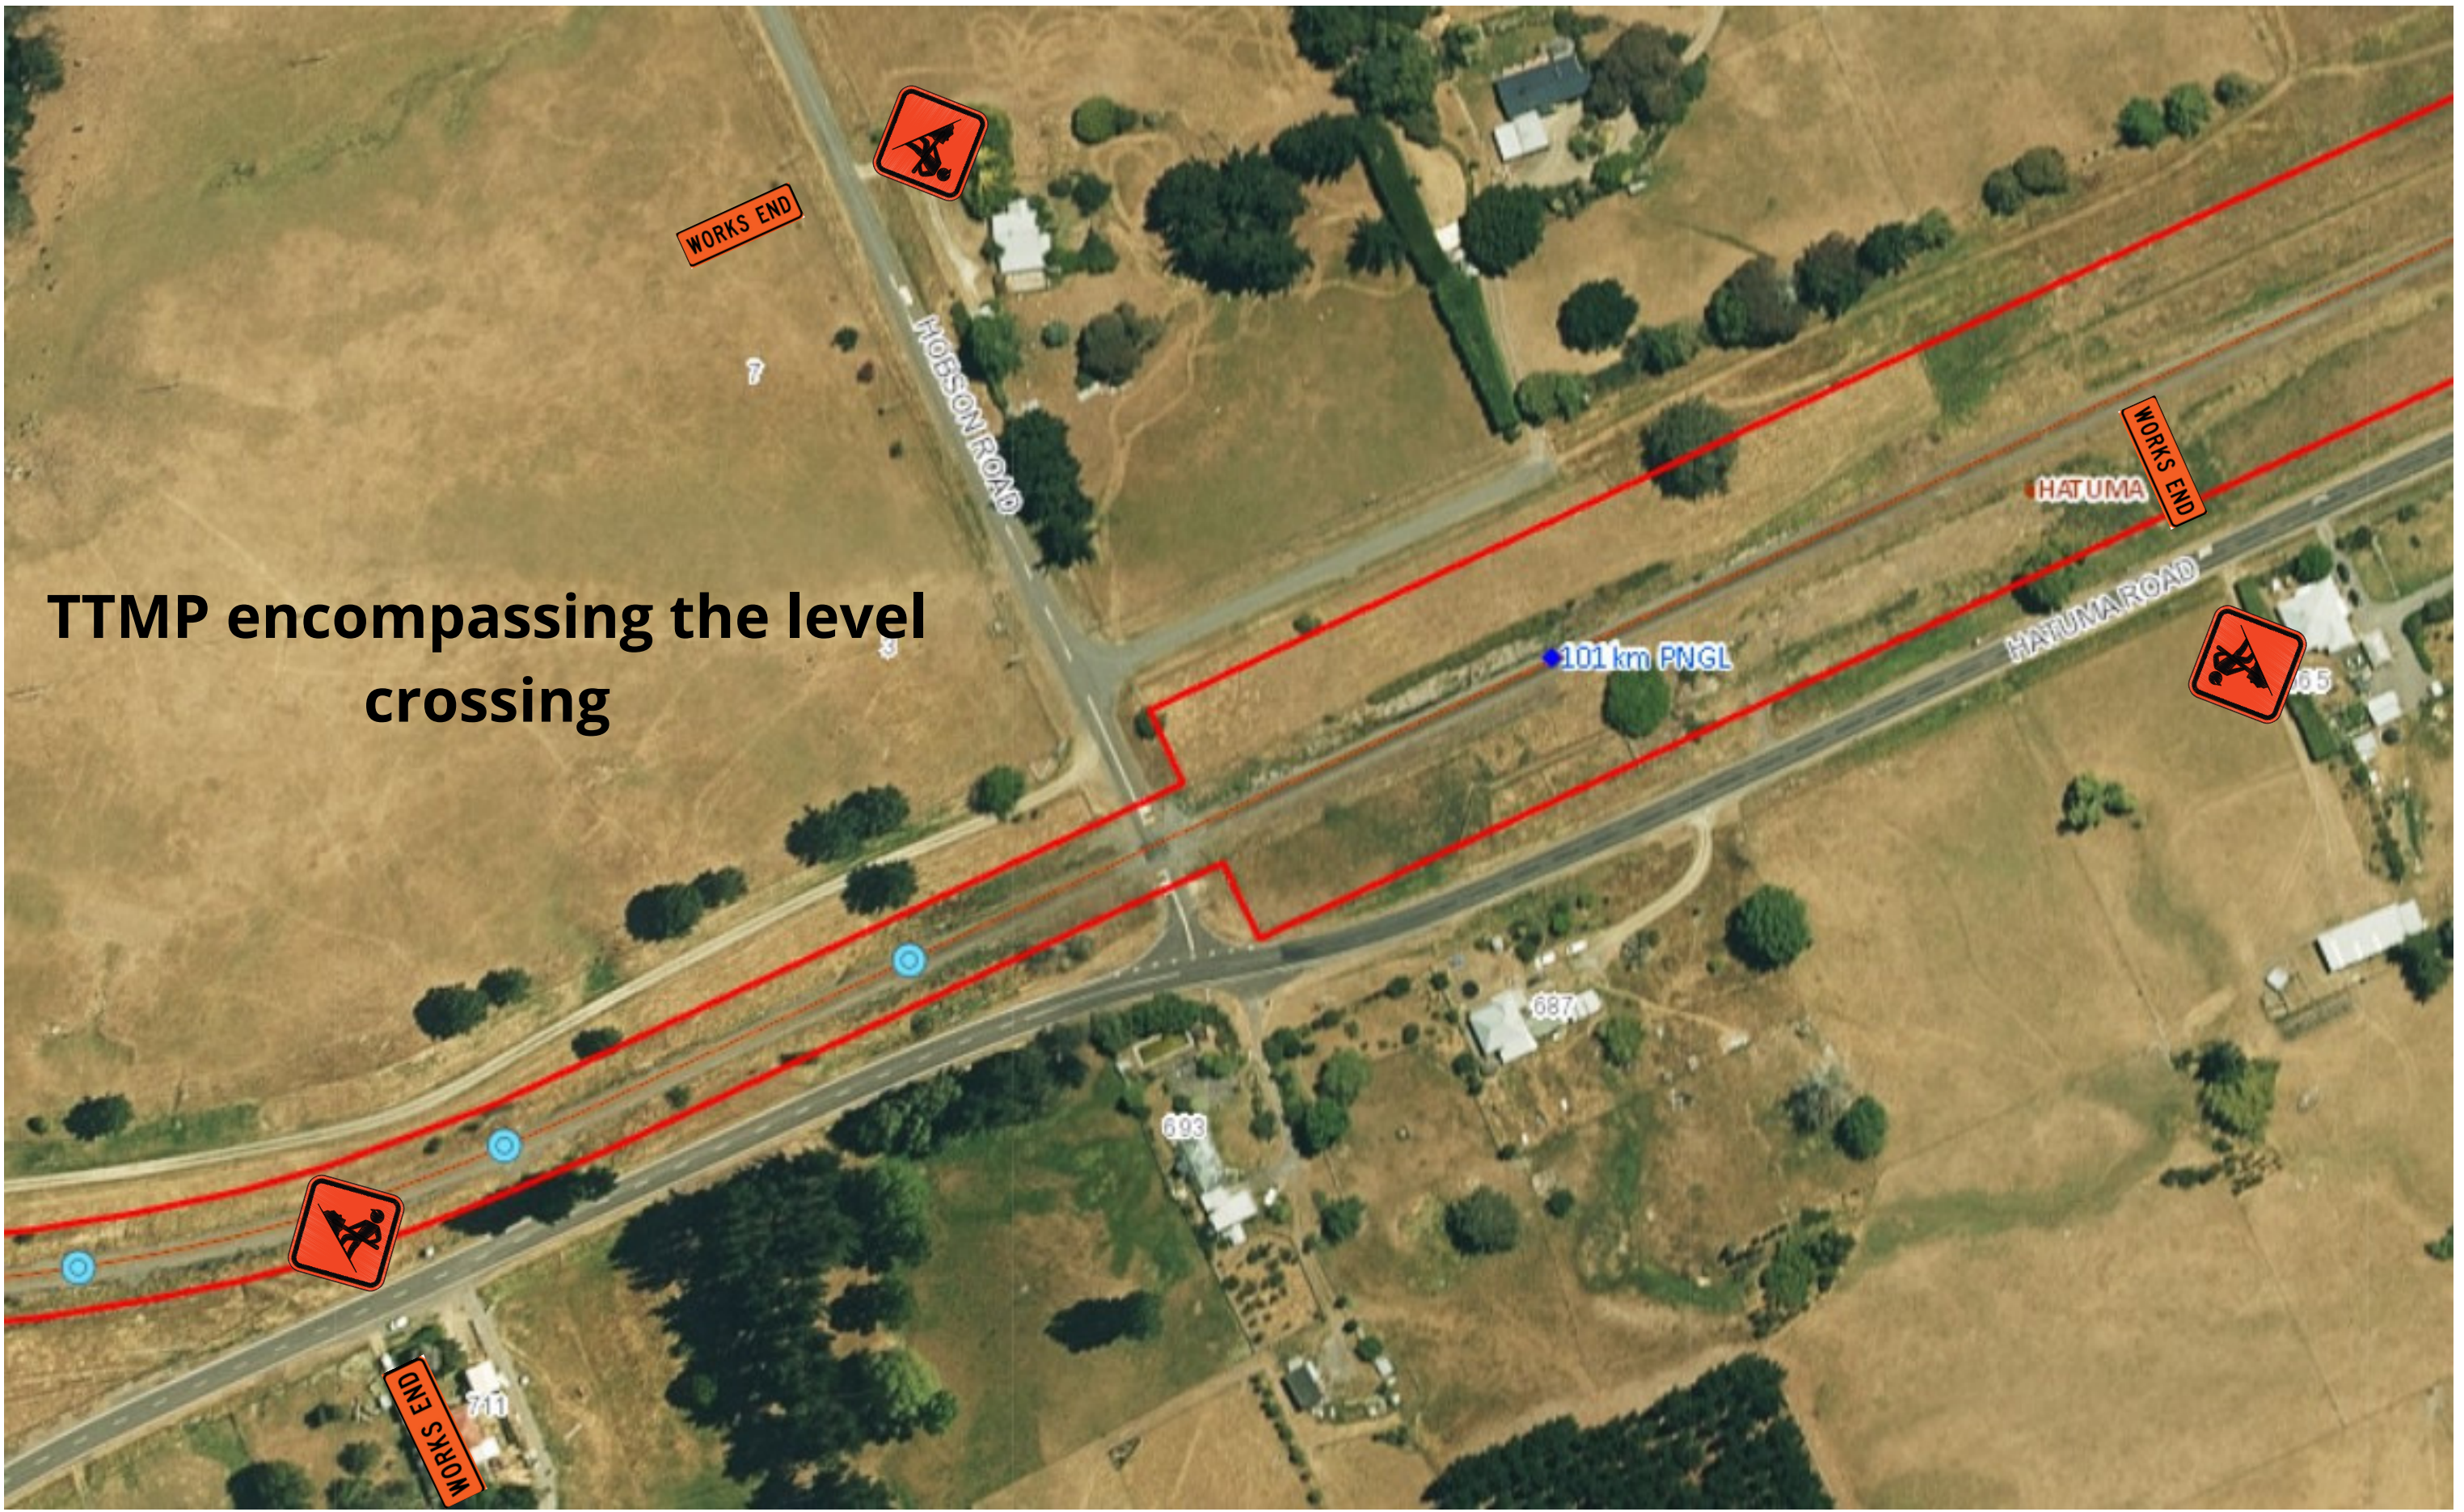
**TTMP encompassing the level crossing**

1. Generic Traffic Management Plans must not be approved by the RCA if within 100m of the rail corridor
2. A KiwiRail Permit to Enter must be obtained by the organization controlling the work activity and/or the temporary traffic management to authorize access to the rail corridor and review traffic management plans. Details and lead times of the Permit to Enter process can be found here: <https://www.kiwirail.co.nz/how-can-we-help/access-the-rail-corridor/>
3. A Rail Protection Officer (RPO) must be appointed and always on site as a rail safety observer where temporary traffic management control at a level crossings involves vehicle users not having **all** the level crossing designed and installed warning systems available, visible or operating. The RPO is responsible for coordinating the road and rail interface risks. This is to be confirmed during the Permit to Enter process.

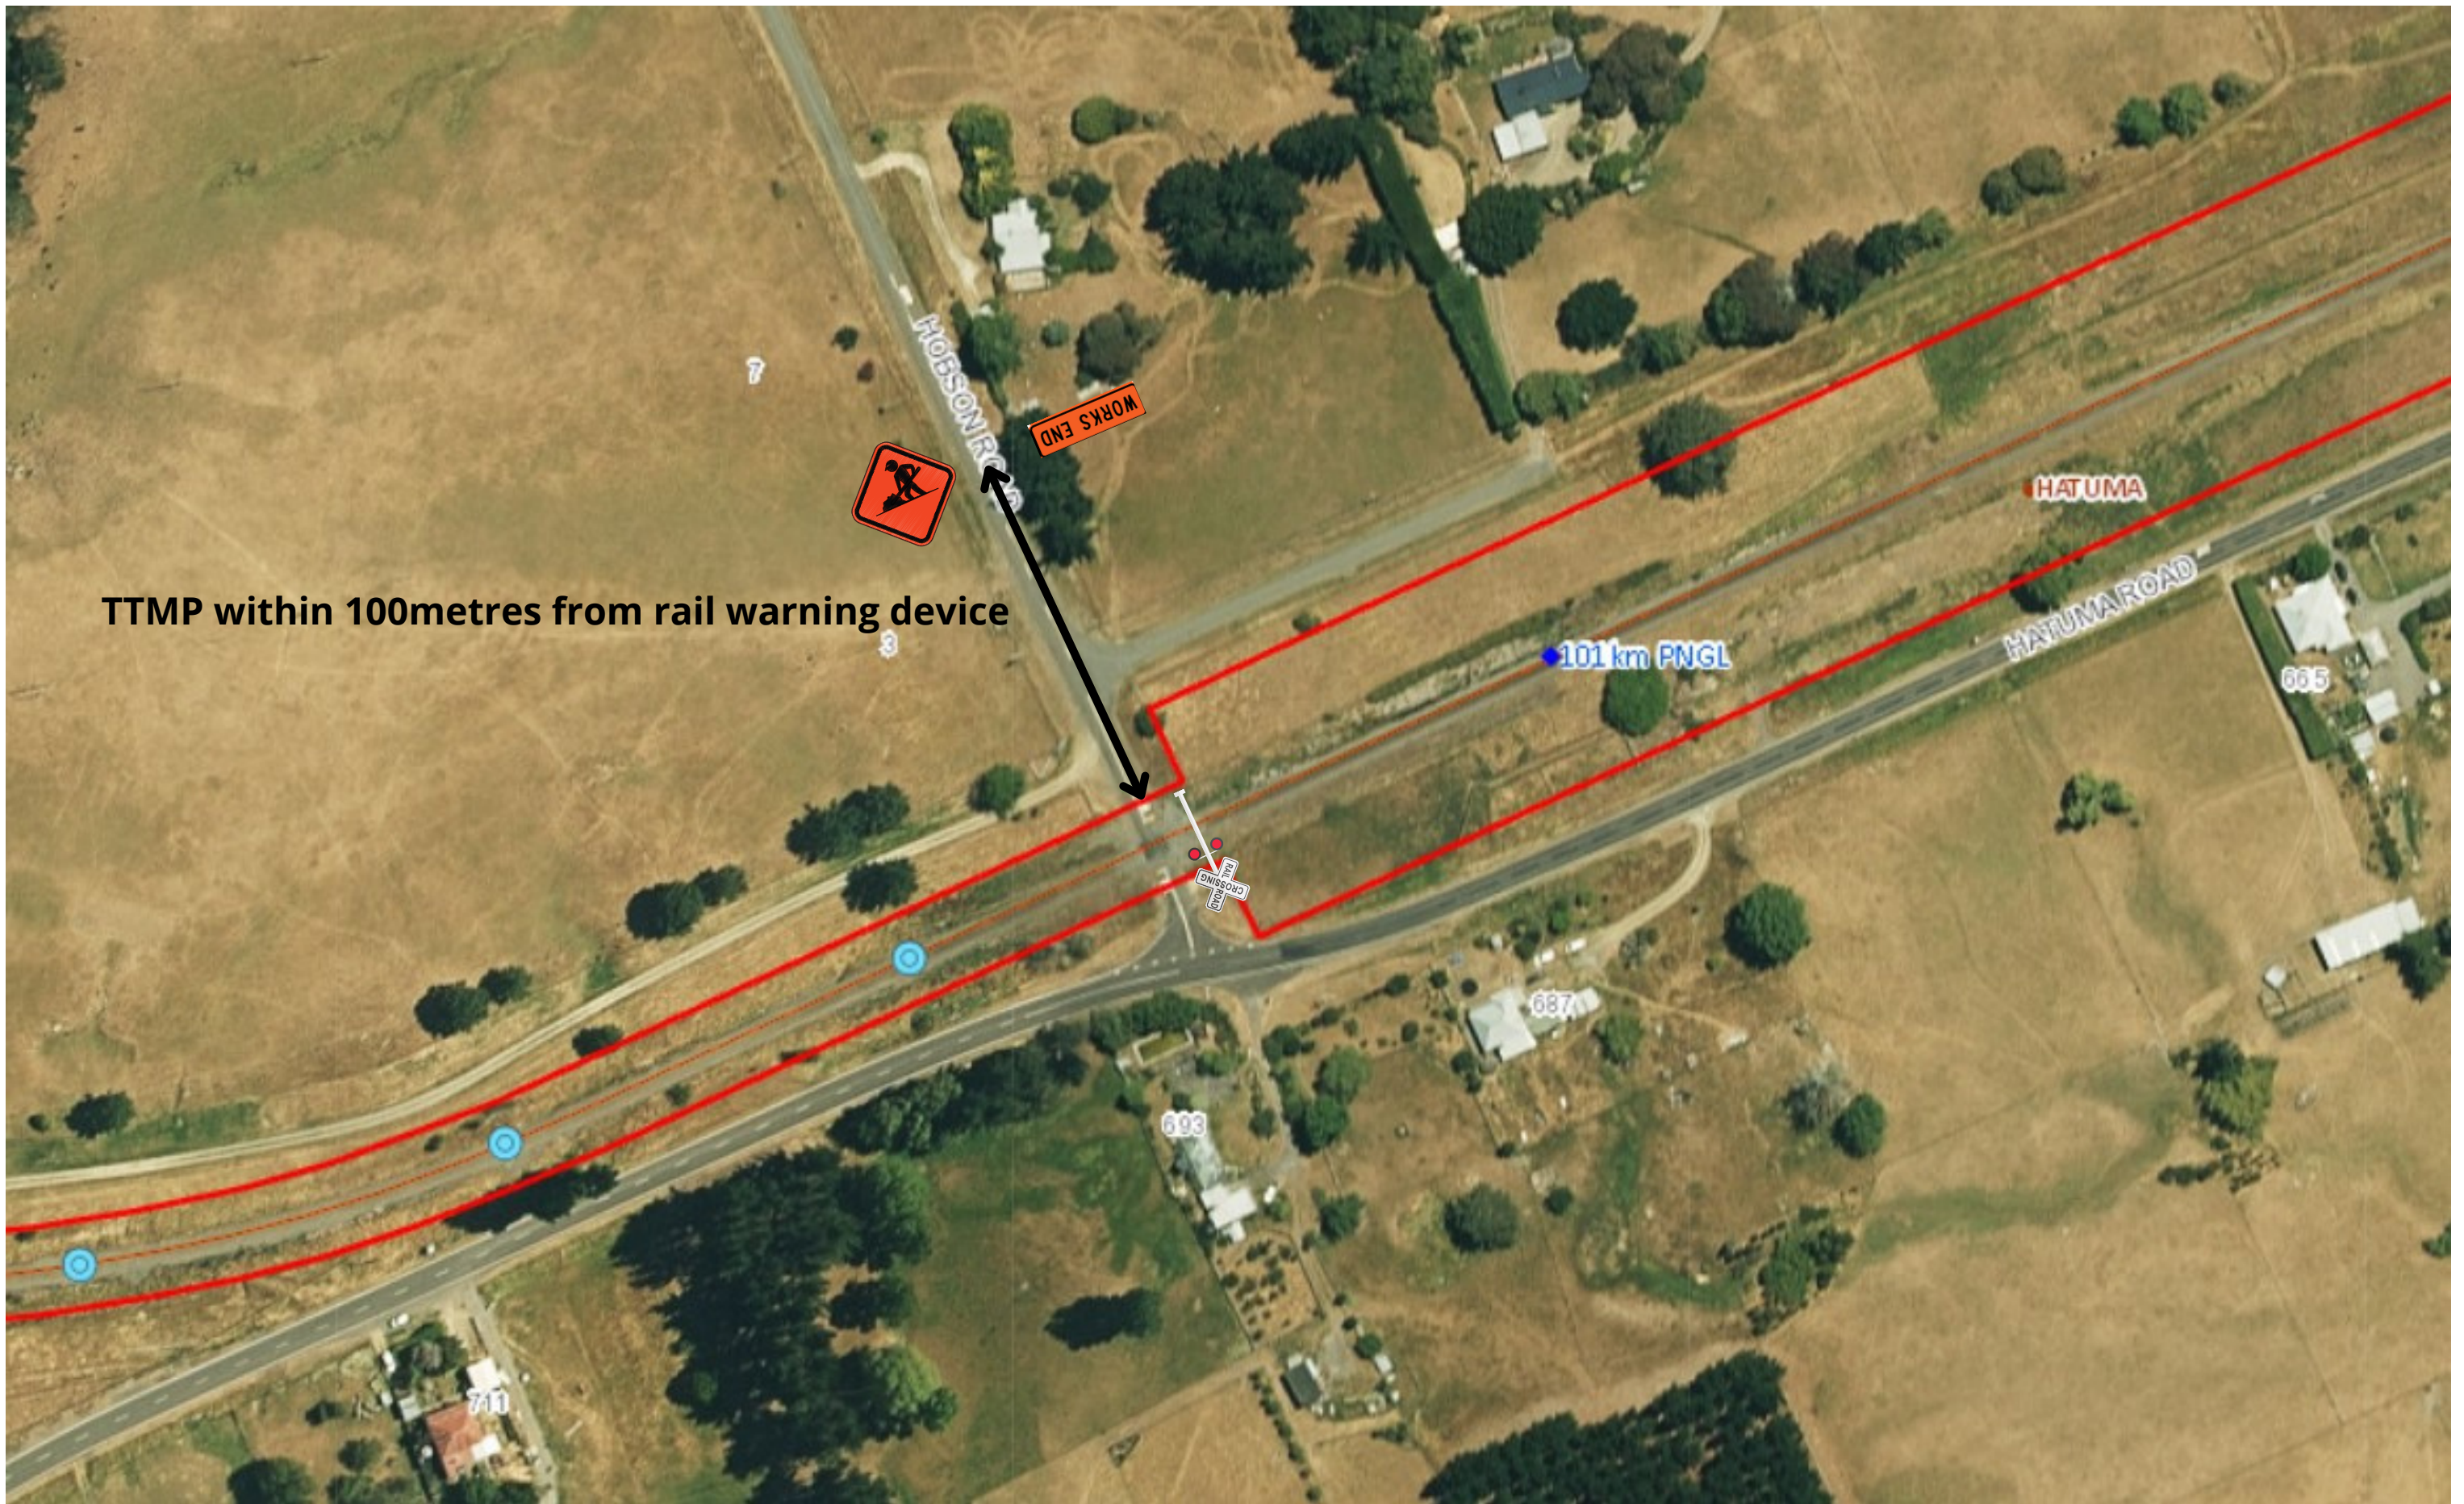
TTMP within 100metres from rail warning device
