<b>Incident Short Description:</b>	Leg entrapment and partial amputation in a Komatsu Hoe Rotor.
------------------------------------	---

**Komatsu GS 360 Stabilizer**

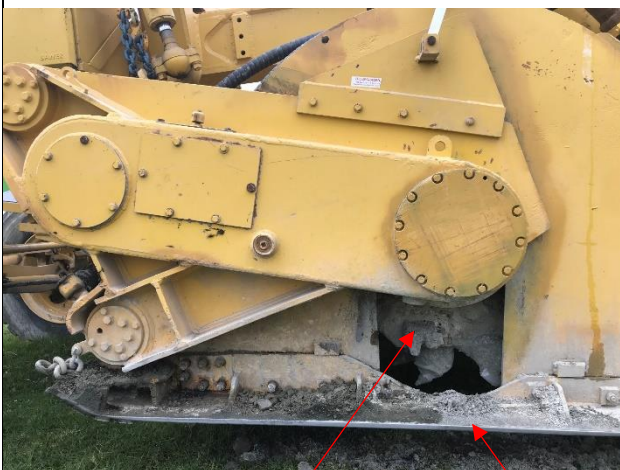
**Void worker's foot and leg entered.**

**Skid**

The picture shows the rotor in the raised position approximately 150mm off the ground. The opening created by the raised rotor drive mechanism is there to allow the rotor drive to enter the exposed space and penetrate the ground below the level of the skid.

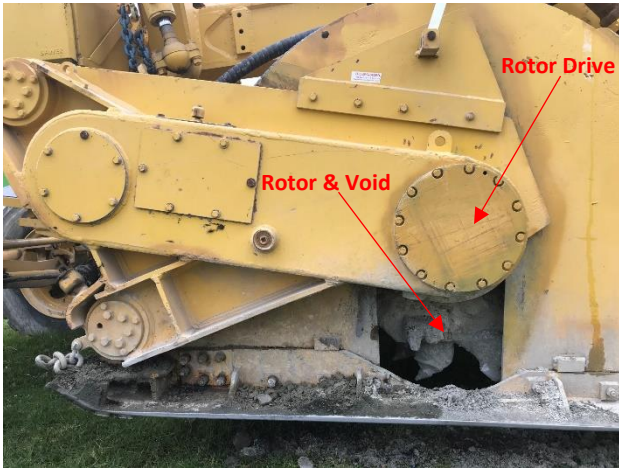
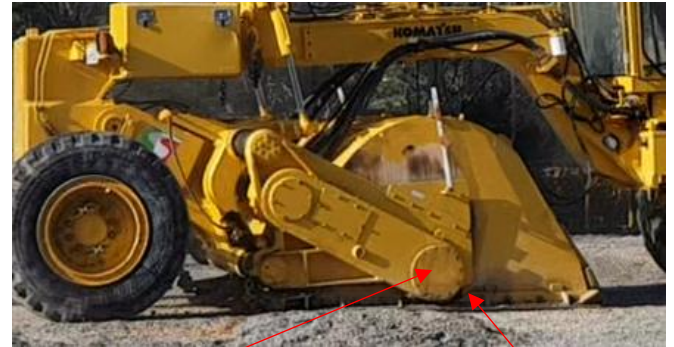
Rotor Drive

Void closed

### Rotor position when not running

The stabilizer is parked and not running the rotor hood assembly, the rotor and rotor drive are placed in the up position. The rotor is stationary and not turning at this time. When assessed during a risk assessment the rotor was stationary and as it not turning does not expose anyone to entanglement or entrapment.

### Rotor position when running

When in operation the rotor drive and the rotor itself descend down into the soil and in doing so close the open void that was visible when stationary. When operating, there are other works near the rotor as it typically is used to carry out road stabilization work adjacent to a live traffic lane.

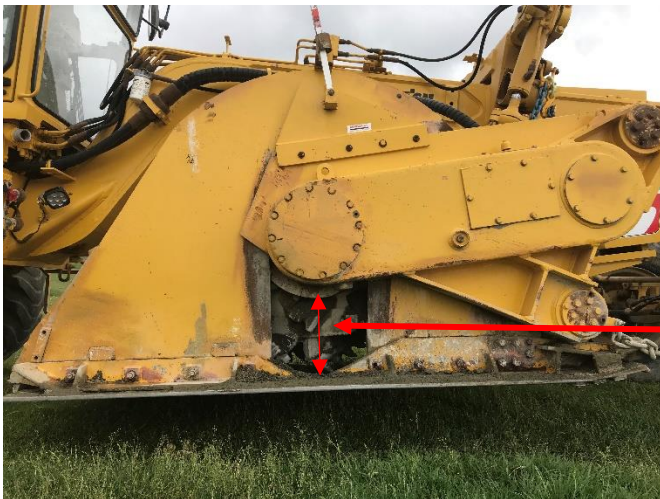
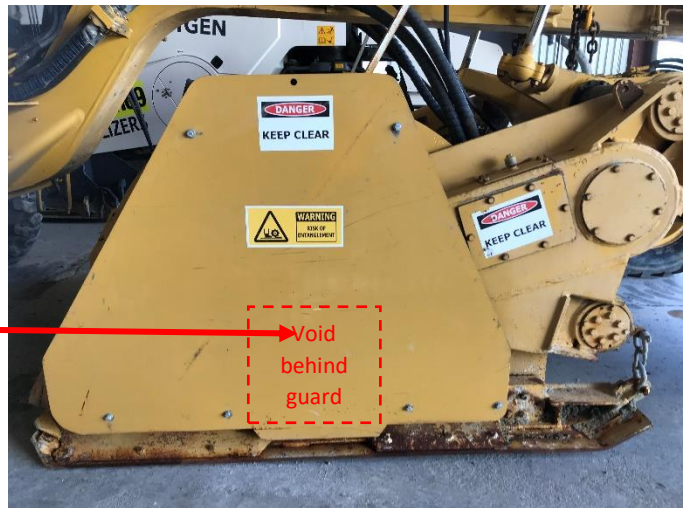
Void behind guard

### Before

The rotor housing has a void below the rotor drive assembly that allows the rotor drive to move into as the rotor cuts down vertically into the soil below.

### After

The void is covered by a guard that prevents access to the void while still allowing for normal operation.

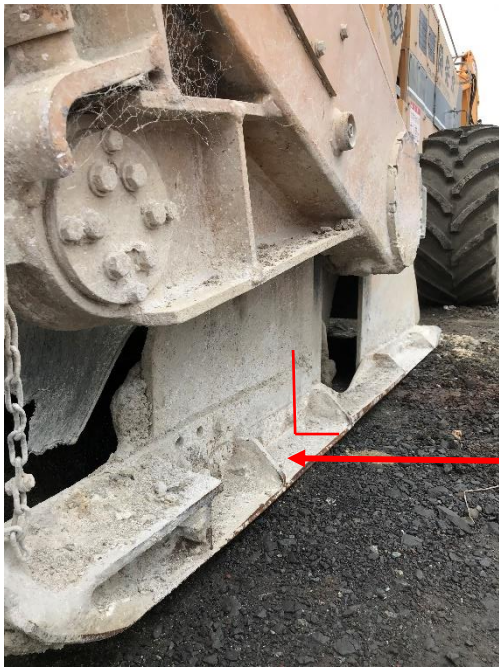
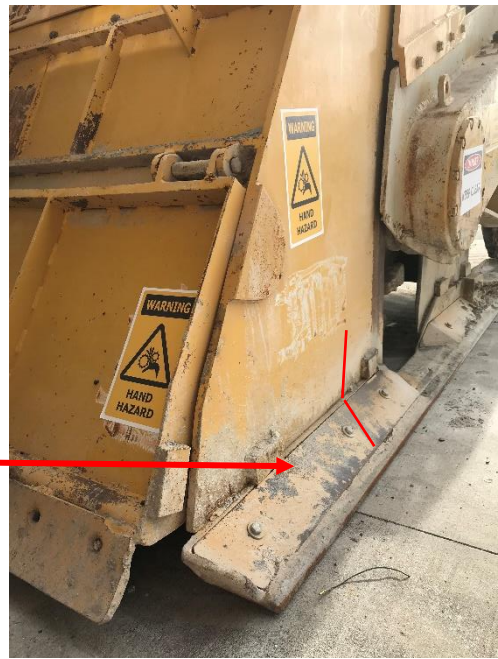
**Before**

The skids fitted to the rotor housing had a flat surface that accumulated soil during operation.

**After**

An inclined plate was fitted to the skid to limit the accumulation of soil during operation, which now slides off the angled surface and is less likely to accumulate, thereby reducing the amount of cleaning that would need to be done after the stabilizer has been operating.

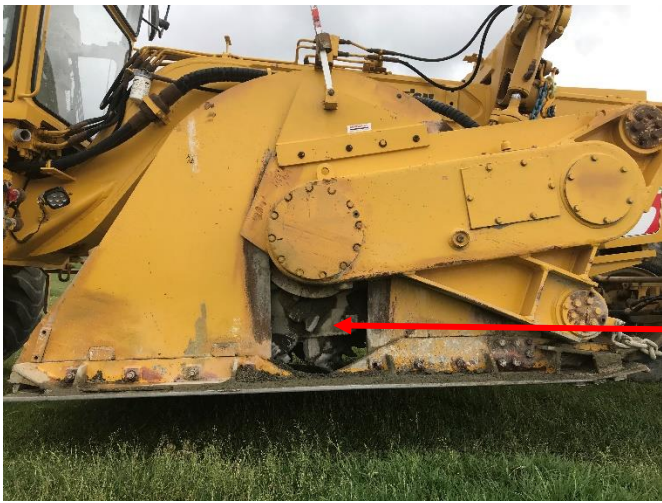
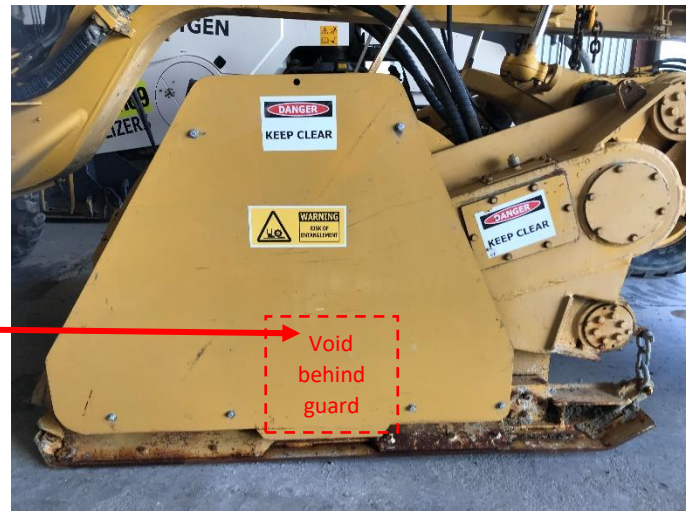
**Before**

The rotor housing has a void below the rotor drive assembly that allows the rotor drive to move into as the rotor cuts down vertically.

**After**

The void is covered by a guard that prevents access to the void while still allowing for normal operation.
