# ALERT

### Temporary Traffic Management and Level Crossing Interface

Issue No.	11	Issue date:	3/05/2021	Originator:	Zero Harm
IRIS No.	EVT2001083EVT2001083			BU reference:	ZH CPAD 008
Content endorsed by:				Related docs:	Code of Practice for Temporary Traffic Management
Content authorised by:	Cat Salt, KiwiRail			Job title:	Zero Harm Lead

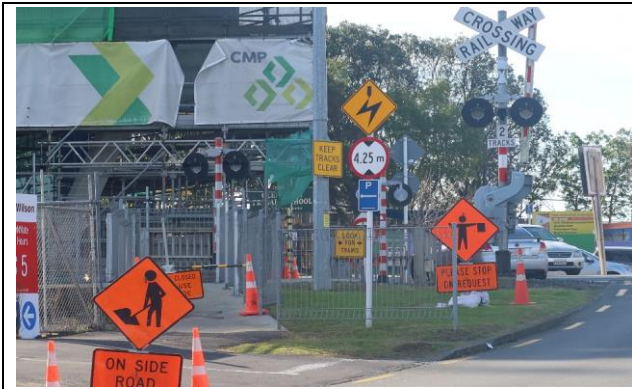
Example of confusing signage as approaching a level crossing.

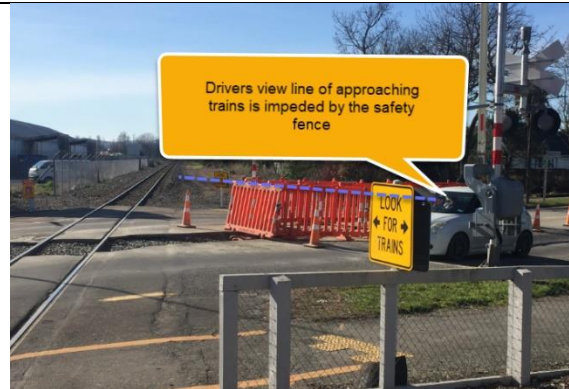
Example of driver view lines where fencing is used in proximity to the rail corridor

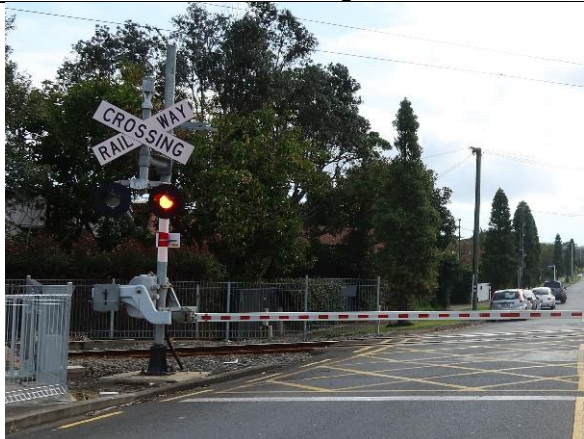
View of signalling when crossing is activated on the correct side of the road

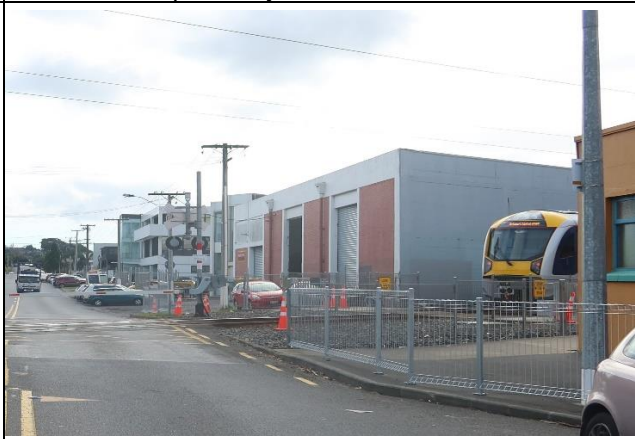
View of signalling when crossing is activated on the wrong side of the road (half-arm barrier has very low visibility and flashing lights are not observable)

- Road users do not have visibility of barrier arms activating, warning lights and signage when crossing on the wrong side of a level crossing.
- Stop/Go instructions create confusion for road users when the worksite incorporates part of the crossing.
- Sign clutter can cause confusion and comprehension overload for road users.

- All traffic management plans to be notified to KiwiRail for approval to ensure it does not impact the level crossing.
- All traffic management plans that encroach within 5m of the crossing will require a KiwiRail Permit to Enter
- To reduce risk where there is direct impact to a railway level crossing traffic management designs must consider:
  1. Closure of the road to avoid a change in road user interaction with the crossing
  2. That road workers are able to maintain a safe distance from the rail corridor
  3. That road users and pedestrians are able to use the crossing as designed – i.e. avoiding crossing the wrong side, or diverting pedestrians

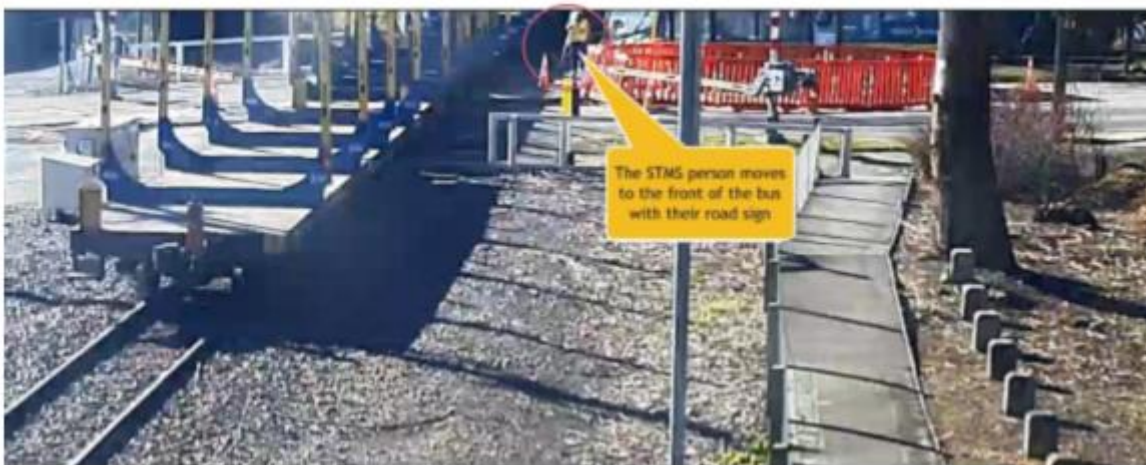
A temporary traffic management system had been established for excavation work being undertaken on Renall Street. The system diverted road users through side roads away from the crossing. A passenger bus service was granted special permission supported by the local council to travel through the worksite and over the wrong side of the crossing. A passenger bus approached the crossing as the half-arm barrier activated blocking the bus from exiting the crossing. The driver stopped the bus and reversed clear of the tracks. Less than 10 seconds later a freight train proceeded over the crossing. As the train is proceeding over the crossing the STMS placed themselves between the front of the bus and the passing train wagons shown in figure 10 below.

Figure 10: STMS person positioned near the front of the bus.

Rail protection and bulletins are required to protect people from rail movements where activity is underway within 5m of the track centre line.
